Arboricultural Report

Tree Survey,
Arboricultural Impact Assessment &
Arboricultural Method Statement

**Slane Road
Drogheda
Co. Louth**

191125-PD-11-A

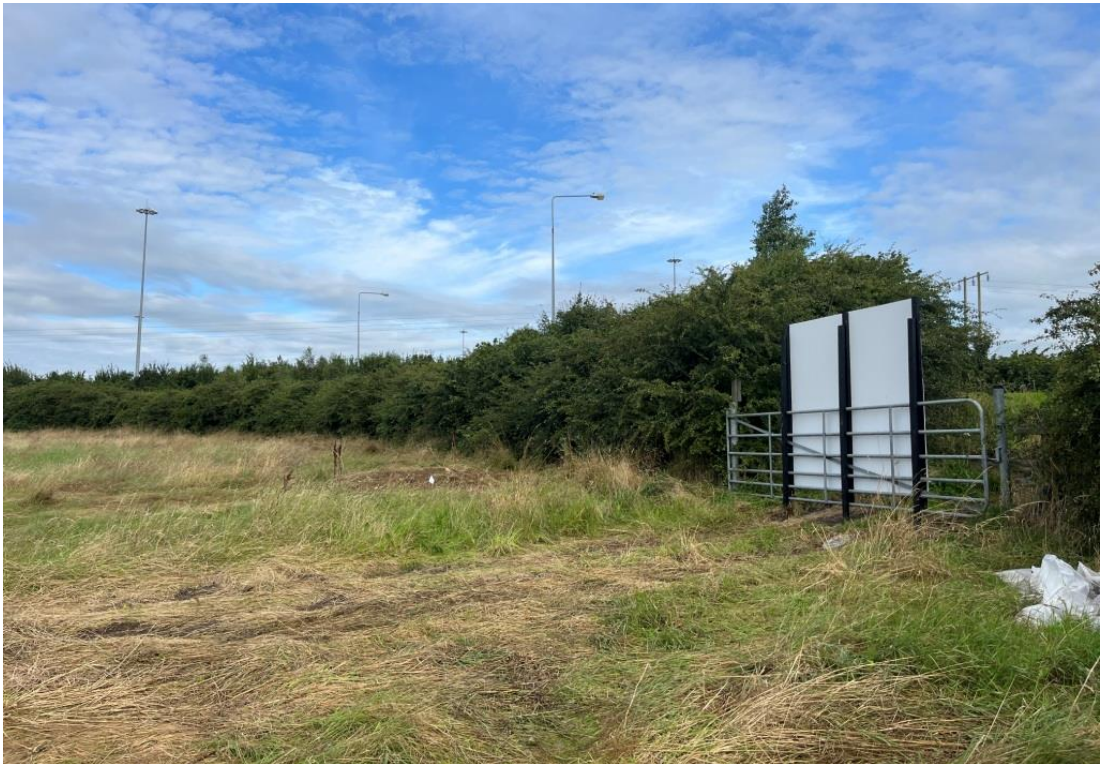
Photo 1: View of the mixed native tree group G928 located adjacent to the northern boundary.

| Tree ID | No. Species | Height (m) | Stem diameter (cm) | No. of Stems | CROWN SPREAD (m) | | | | | | | | Crown clearance (m) | L.B. (m) | Life stage | Condition Notes | Survey date | RPA (m ²) | RPR (m) | Life expectancy (yrs) | BS Category |
|---|--|---|---|---|---|---|---|---|---|---|---|---|---|---|---|--|---|---|---|---|---|
| Group G928 | 20 Acer campestre (Field Maple) | 4.0 | 10 AVE | 1 | | | | | | | | | 0.0 | | Semi Mature | Structural condition Good. Physiological condition Good. Arboricultural work - Historic. Competition - Adjacent trees. Young planted tree / trees. Height and stem diameter are average for group. Mixed group of young and semi-mature trees planted as a shelterbelt between site fence line and road. Hawthorn on site side along fence overhanging boundary by approx. 1.5-2.5m. Quantities are estimated only. Ownership unknown. | 24/07/2023 | 4.5 | 1.2 | 40+ | C2 |

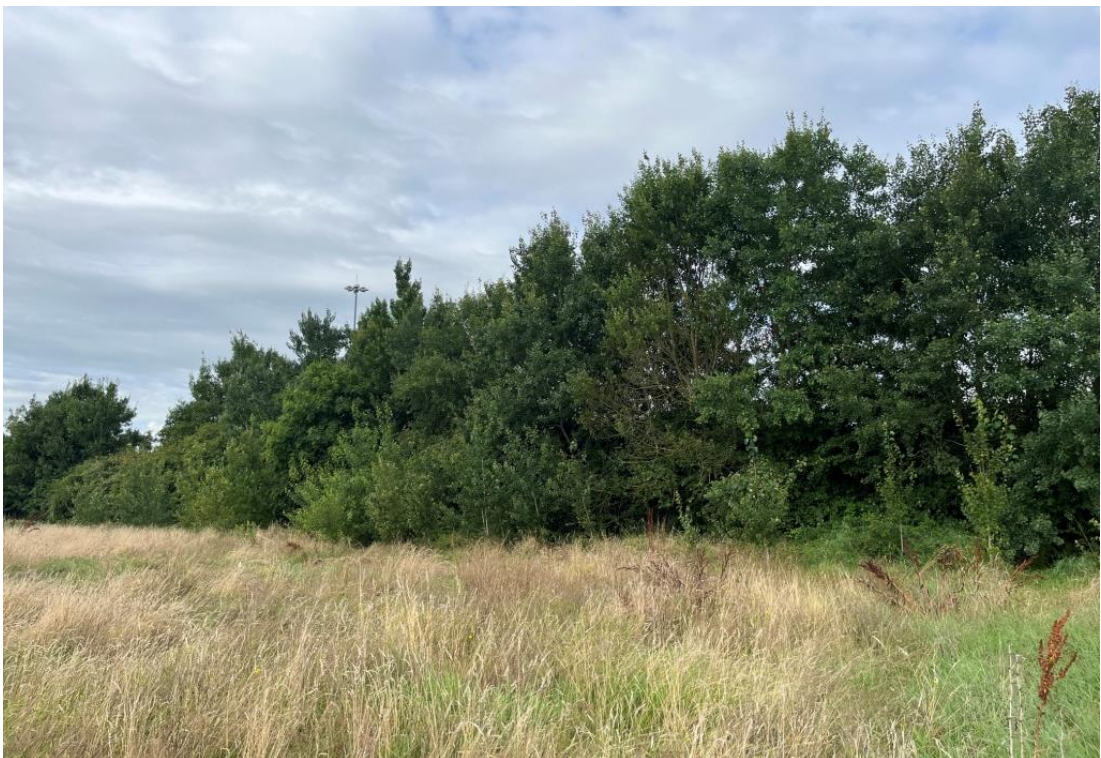
Photo 2: View of the mixed tree and hedgerow group G930 located adjacent to the western boundary.

| Tree ID | No. Species | Height (m) | Stem diameter (cm) | No. of Stems | CROWN SPREAD (m) | | | | | | | | Crown clearance (m) | L.B. (m) | Life stage | Condition Notes | Survey date | RPA (m ²) | RPR (m) | Life expectancy (yrs) | BS Category |
|---|--|---|---|---|---|---|---|---|---|---|---|---|---|---|---|--|---|---|---|---|---|
| Group G930 | 400 Crataegus monogyna (Common Hawthorn/Quick/May) | 2.0 | 20 AVE | 1 | | | | | | | | | 0.0 | | Early Mature | Structural condition Good. Physiological condition Good. Arboricultural work - Historic. Competition - Adjacent trees. Height and stem diameter are average for group. Mixed group consisting of hawthorn along site boundary fence line and overstorey poplar trees. The hawthorn along the boundary have been managed as a hedgerow in the past. Lateral growth of trees overhanging into site boundary by 2-4.5m. Most extensive overhang is just south of the gorse. Trees have been planted as a shelterbelt between site fence line and road. Poplar trees immediately behind fence line are approx. 20-25cm diameter. Quantities are estimated only. Ownership unknown. | 24/07/2023 | 18.1 | 2.4 | 40+ | C2 |

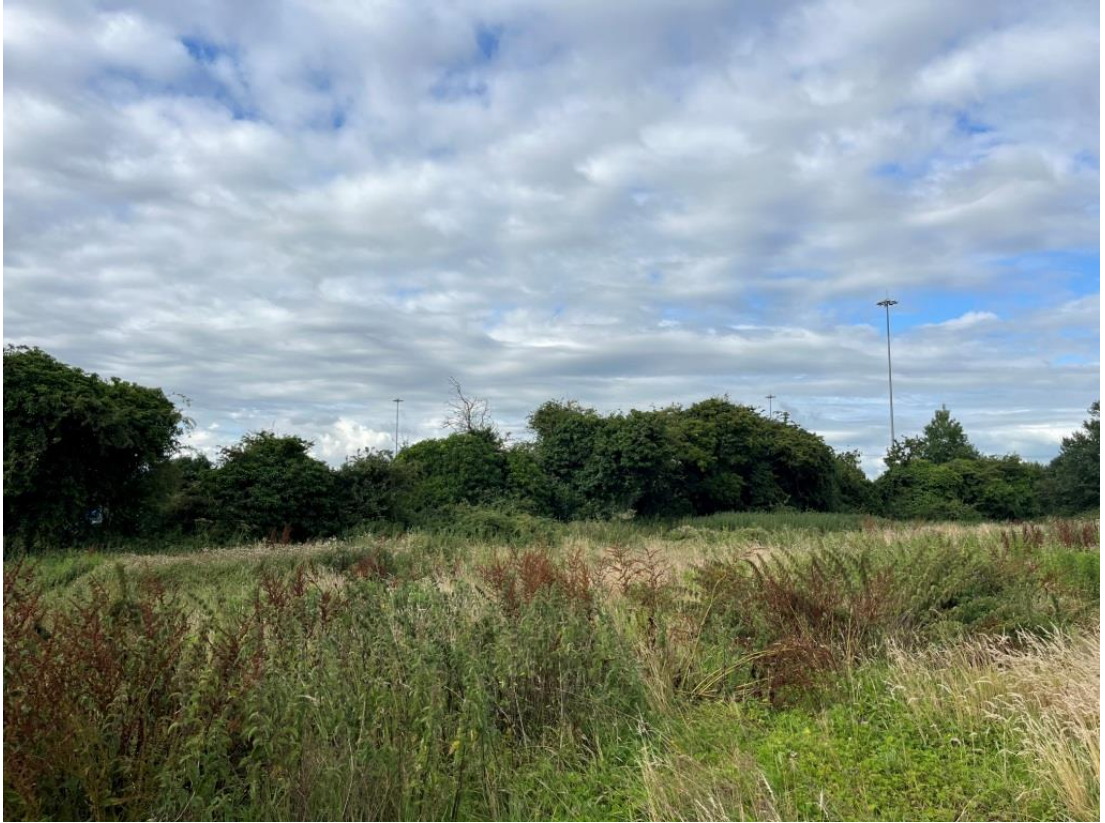
Photo 3: *View of the native hedgerow H931.*

| Tree ID | No. Species | Height (m) | Stem diameter (cm) | No. of Stems | CROWN SPREAD (m) | | | | | | | | Crown clearance (m) | L.B. (m) | Life stage | Condition Notes | Survey date | RPA (m ²) | RPR (m) | Life expectancy (yrs) | BS Category |
|---|---|---|---|---|---|---|---|---|---|---|---|---|---|---|---|--|---|---|---|---|---|
| Hedge H931 | 25 Crataegus monogyna (Common Hawthorn/Quick/May) | 7.0 | 30 AVE | 1 | | | | | | | | | 0.0 | | Mature | Structural condition Fair. Physiological condition Fair. Arboricultural work - Historic. Competition - Adjacent trees. Deadwood - Minor. Hedgerow - Neglected / overgrown. Ivy or climbing plant. Height and stem diameter are average for group. Mature hawthorn hedgerow that has been neglected and contains several gaps with trees covered in ivy. Quantities are estimated only. | 24/07/2023 | 40.7 | 3.6 | 20-40 | C2 |

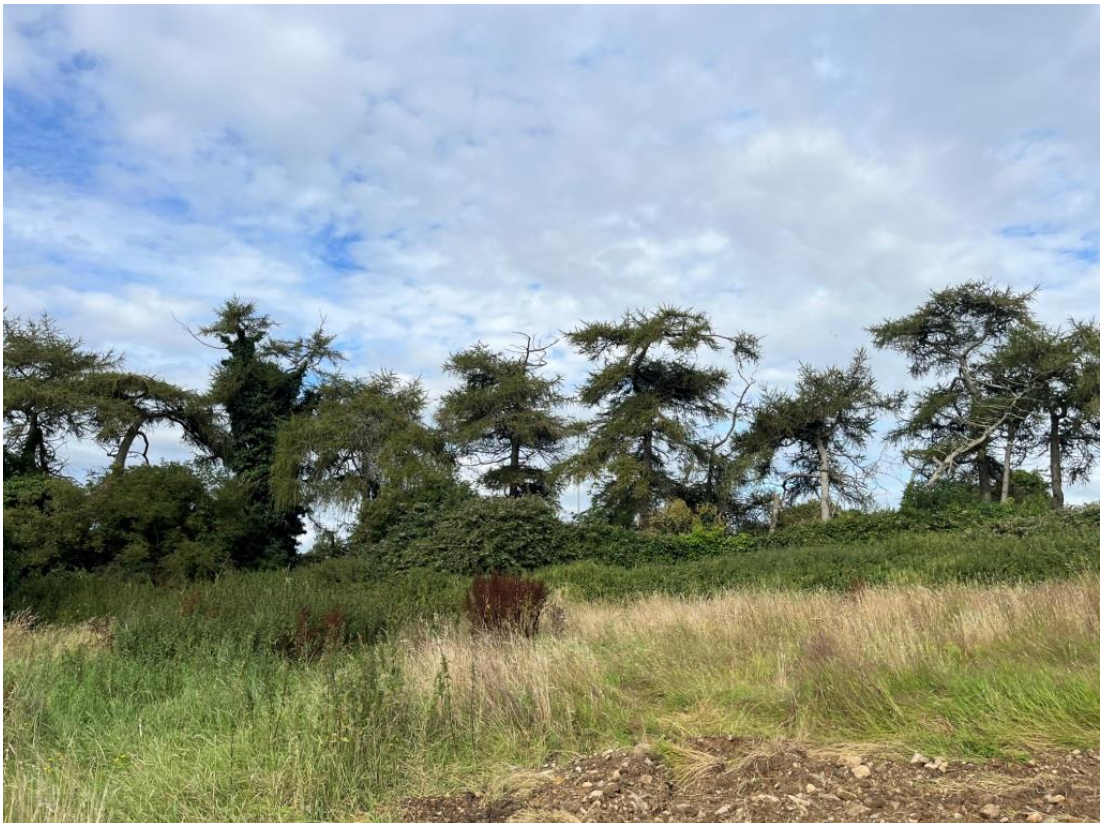
Photo 4: *View of the larch trees T964 to T977 located along the western boundary of the southern section of the site.*

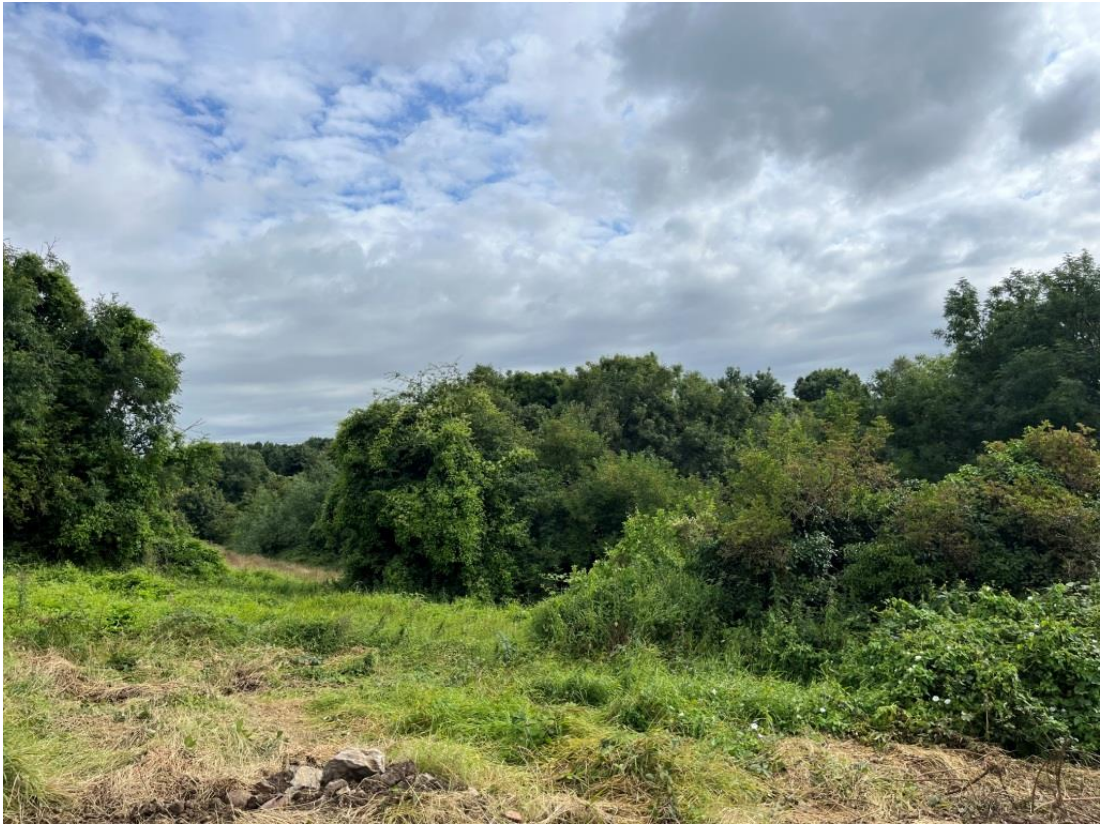
Photo 5: *View of the native tree group G943.*

| Tree ID | No. Species | Height (m) | Stem diameter (cm) | No. of Stems | CROWN SPREAD (m) | | | | | | | | Crown clearance (m) | L.B. (m) | Life stage | Condition Notes | Survey date | RPA (m ²) | RPR (m) | Life expectancy (yrs) | BS Category |
|---|--|---|---|---|---|---|---|---|---|---|---|---|---|---|---|---|---|---|---|---|---|
| Group G943 | 5 Sambucus nigra (Elder) | 5.0 | 15 AVE | 1 | | | | | | | | | 0.0 | | Early Mature | Structural condition Fair. Physiological condition Fair. Ivy or climbing plant. Natural regeneration. Height and stem diameter are average for group. Area of naturally regenerated vegetation. Quantities are estimated only. | 24/07/2023 | 10.2 | 1.8 | 10-20 | C1 |

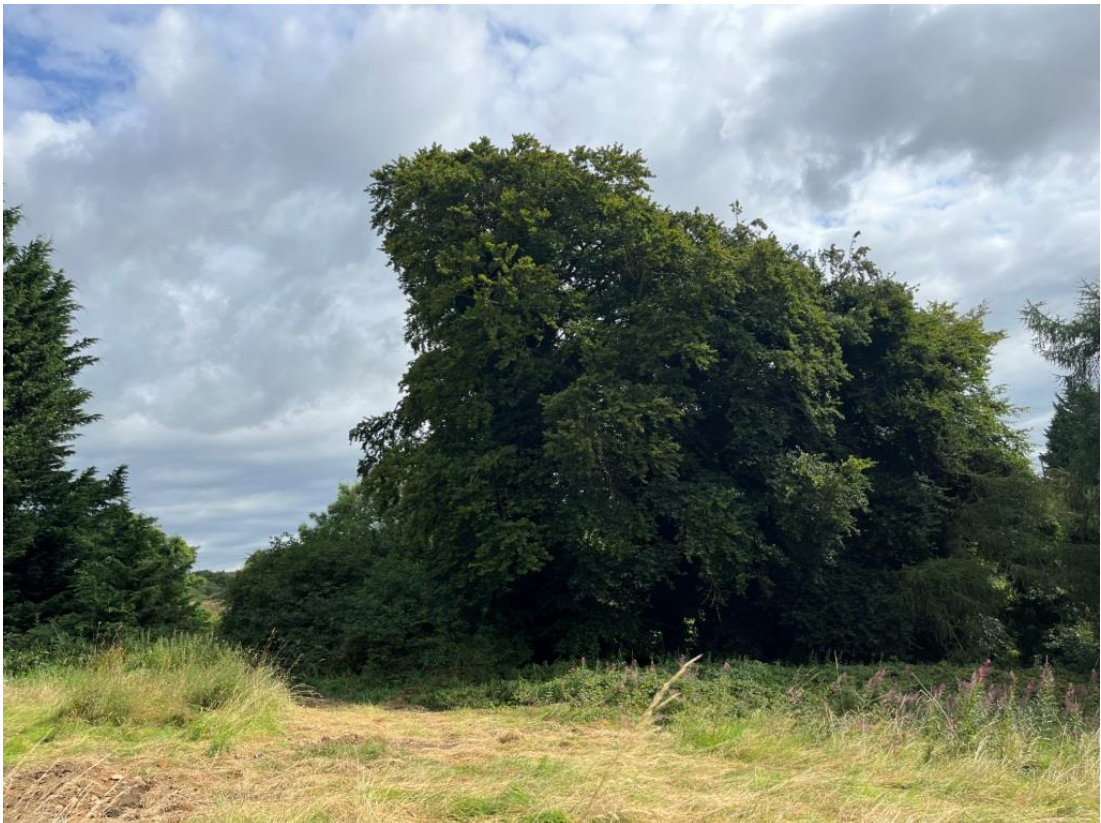
Photo 6: *View of the mature beech trees T995 to T998.*

- 6.11 **Construction operations** – Excavation works are required to construct the proposed road within the RPA of the B Category beech tree T995. This incursion is only minor and is located at the periphery of the tree’s root protection area, where significant roots are unlikely to be present. It is not considered at all likely that these works will have a detrimental impact on the long term health and structural condition of the tree.

- 6.13 A no-dig design involves constructing the hard surface above the existing ground level using a cellular confinement system, or similar approved, please refer to Appendix C. The finishing surface material must be permeable in order to maintain water infiltration and gaseous exchange within tree rooting areas. This will ensure that damage does not occur to the roots of the trees or the structure and function of the soil in which they are growing.

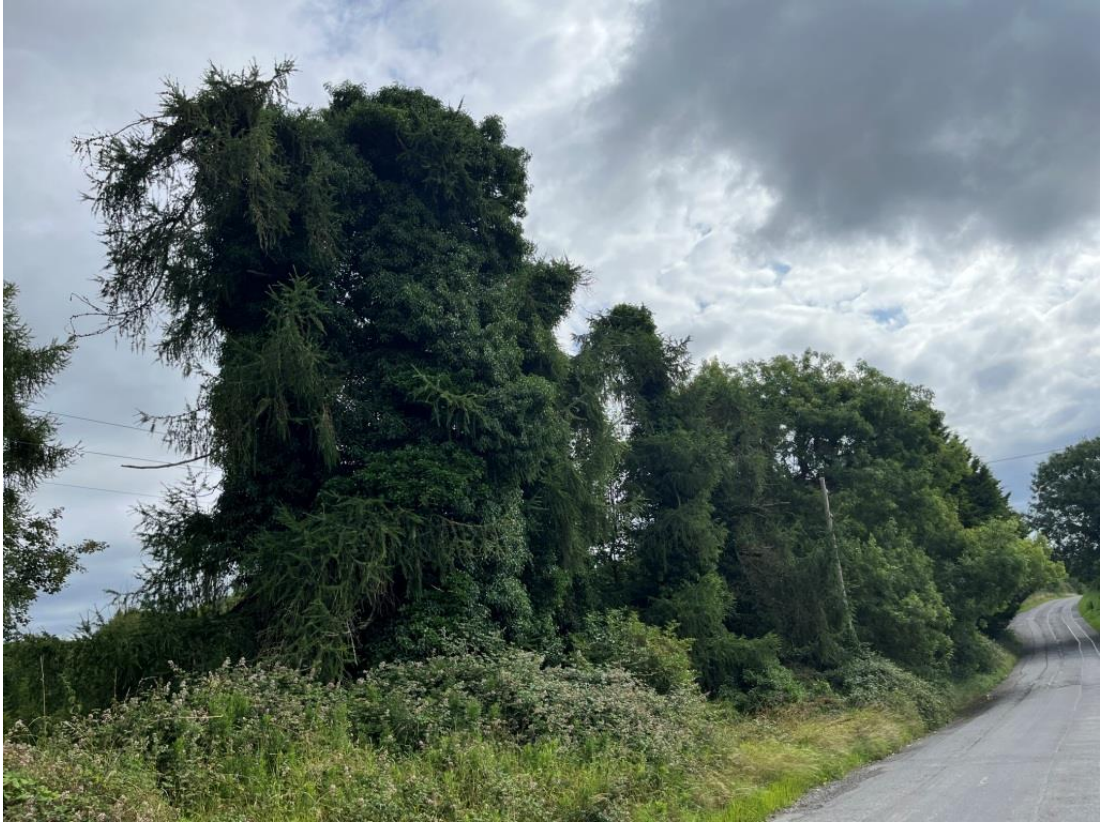
Photo 7: View of the larch trees T954 to T960 located adjacent to Slane Road.

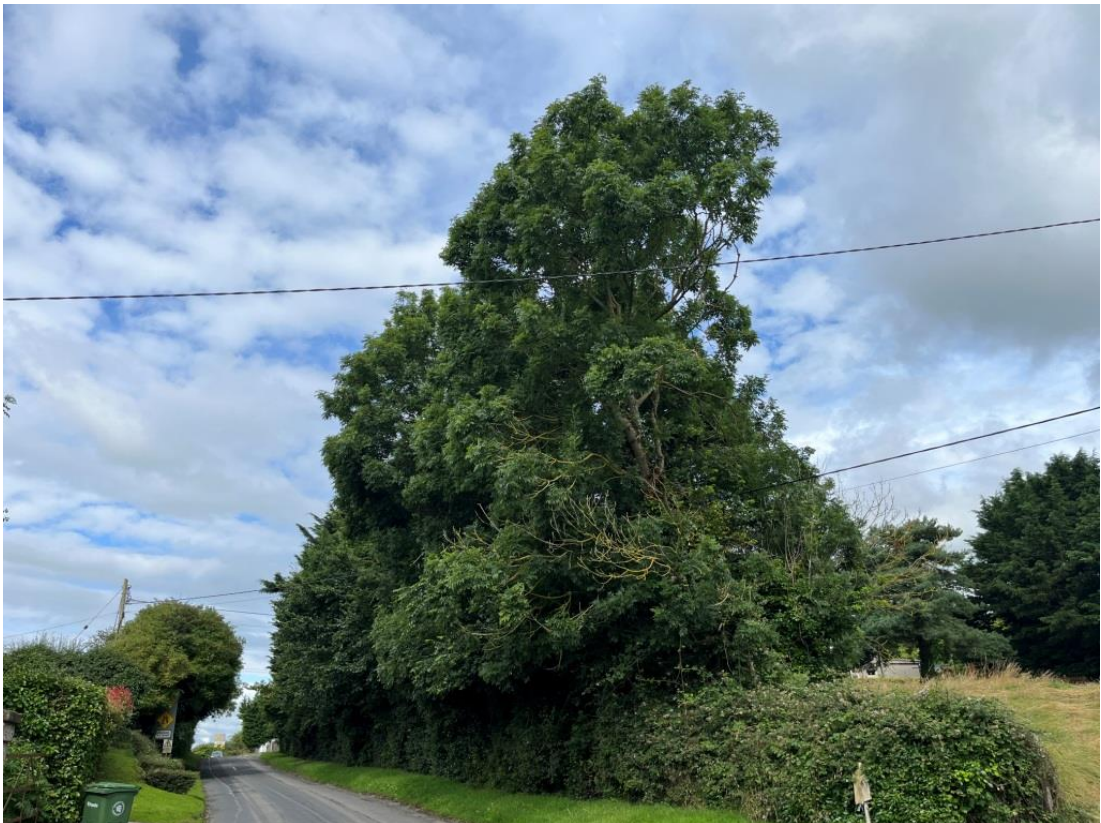
Photo 8: View of the mature ash trees T1002 and T1003 located adjacent to Slane Road.
